UNDERWATER BRIDGE INSPECTION REPORT

STRUCTURE NO. 6610

MINNESOTA RIVER

COLLINS ENGINEERS, INC.

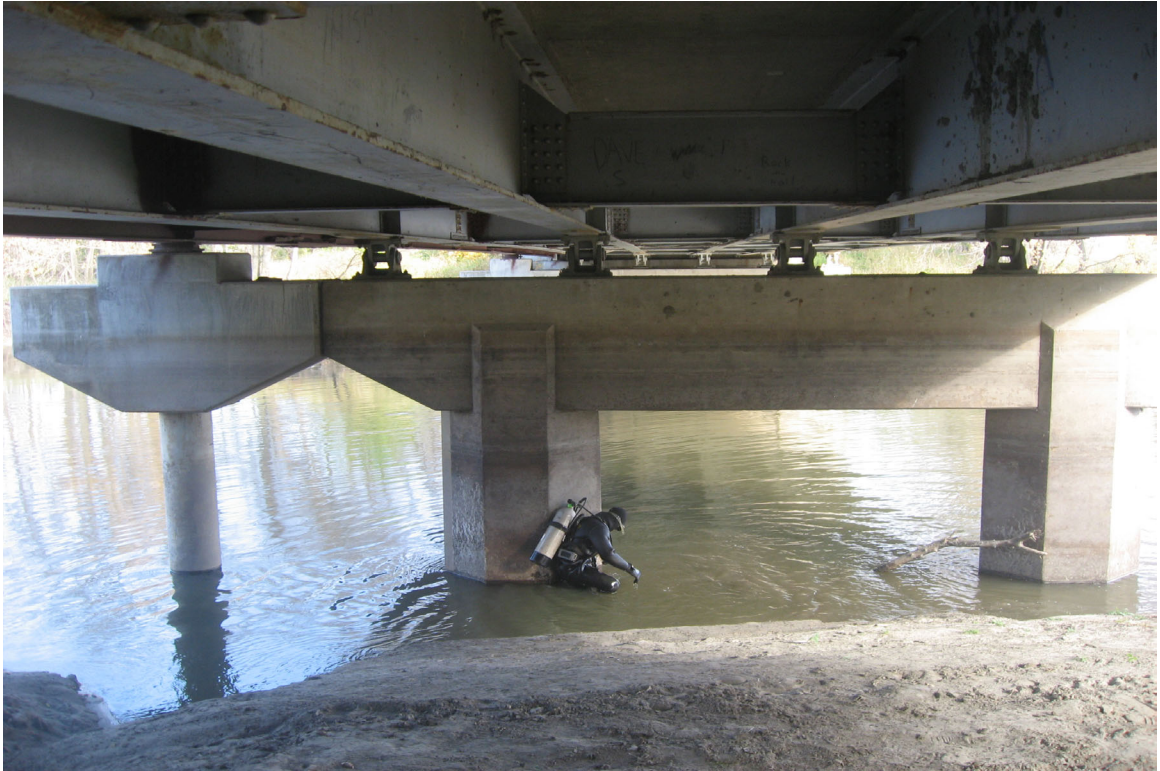
Photograph 1. View of Pier 1, Looking East.

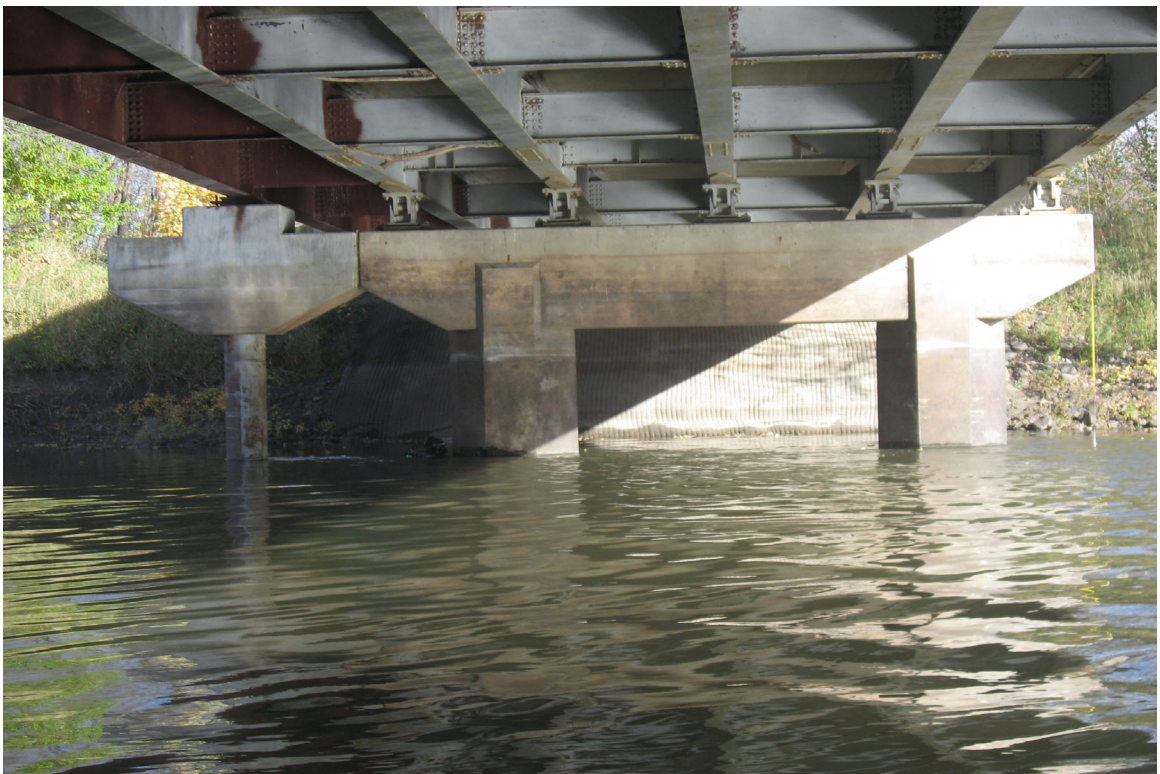
Photograph 2. View of Pier 2, Looking East.

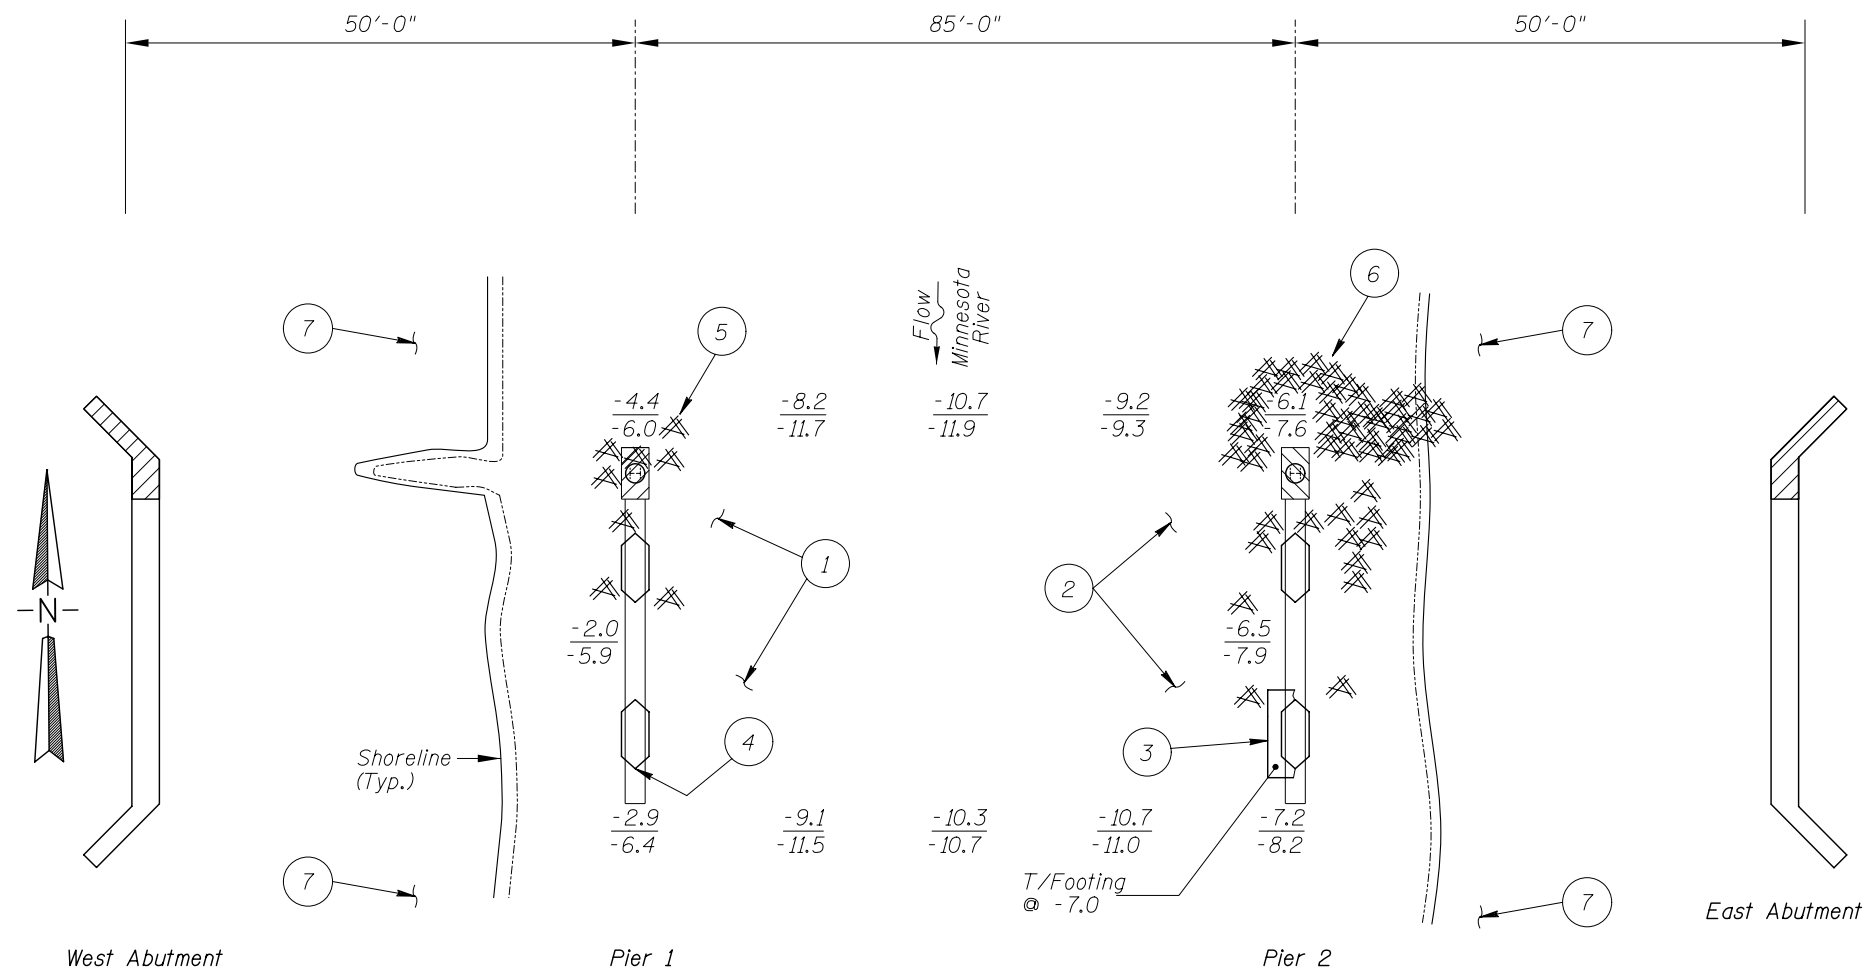
SOUNDING PLAN

- INSPECTION NOTES:
- The channel bottom material around Pier 1 consisted of silty sand with approximately 6 inches of probe rod penetration.
 - The channel bottom material around Pier 2 consisted of cobbles, 6 inch diameter riprap, and sandy silt with 4 inches of probe rod penetration.

- The footing was exposed at the west side at the downstream column of Pier 2 with a maximum vertical exposure of 6 inches.
 - A light area of section loss was observed 2 feet above the waterline at the downstream nose of Pier 1, measuring 3 square inches with 1 inch of penetration.

- A light accumulation of timber debris, consisting of 6 to 8 inch diameter branches, was observed at the upstream nose of Pier 1 and extended along both sides of the pier.

- A light to moderate accumulation of timber debris, consisting of up to 1 foot diameter logs, was observed at the upstream nose of Pier 2 and extended to the shoreline, and a light accumulation of timber debris extended along both sides of the pier.

- Heavy bank erosion resulting in vertical slopes upstream and downstream of the structure on the east and west banks. Banks are well protected at structure with up to 2 foot diameter riprap and concrete revetment. The west embankment protection was covered with silty sand.
